# The use of ALS, botanical, and soil data to monitor the environmental hazards and regeneration capacity of areas devastated by highway construction

**Abstract** The impact of viaduct construction on the vegetation of a river valley was studied in Central Poland (Natura 2000 site PLH100006). The research aimed at assessing the suitability of ALS (airborne laser scanning), soil, and botanical data for monitoring the environmental effects of right-of-way reclamation 1 year after the road construction. Based on the data mentioned above, the following problems were identified: changes in topography and hydrological conditions of the valley as a result of improper land levelling, the use of inadequate soil for reclamation, no spontaneous regeneration of natural vegetation along the entire right-of-way, as well as the abundant occurrence of invasive species. The results of analysis were used to define strategies for mitigation of adverse impacts of the viaduct construction.

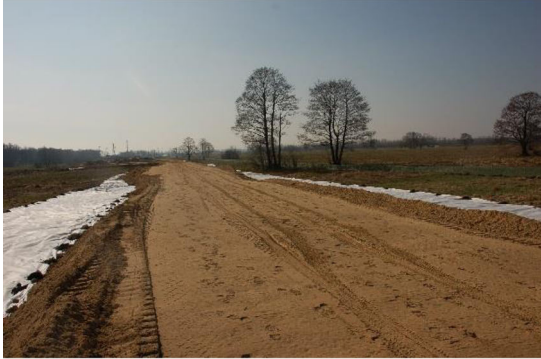
Time	Description of construction works	Photographic documentation
11.2010 – 04.2011	Construction of a haulage road on a ca.1-m high embankment along the western right-of-way limit and platforms for boring rigs. The road was constructed of sand and improved with construction rubble. The road was created without stripping the top peat layer, as a result of which the existing vegetation was covered. At that time, patches of wetland vegetation were destroyed under the haulage road and under the piers.

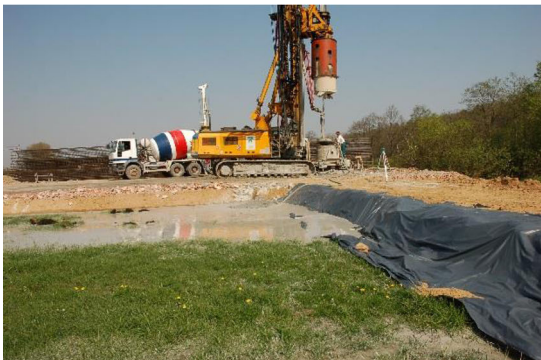
11.2010 – 08.2011	Construction of 40 piers of the viaduct, which involved making 42 boreholes for each of them to the designed depth of 15–25 m. Subsequently, all boreholes were filled with the concrete mix. The spoil produced during the pile boring was hauled away from the ice-marginal valley on an ongoing basis. During these works, vegetation patches between the piers were destroyed, while heavy construction machinery traffic resulted in a considerable soil compaction.

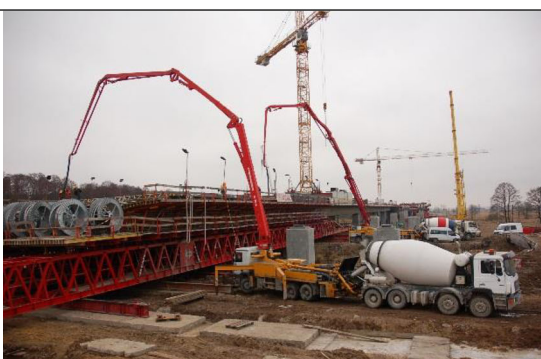
06.2011 – 04.2012	Construction of the motorway's superstructure. Heavy construction machinery traffic results in a further soil compaction.

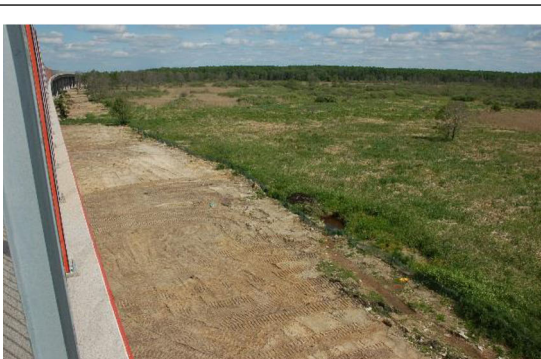
04.2012 – 08.2012	Deconstruction of the haulage road – terrain levelling. The material brought during construction and used for the construction of the haulage road was partly taken out and hauled away. The remaining material (sand and rubble) was spread around the road right-of-way area. As a result of leaving considerable quantities of earth material, an earthen embankment with a maximum height of ca.1.0 m was formed under the viaduct.

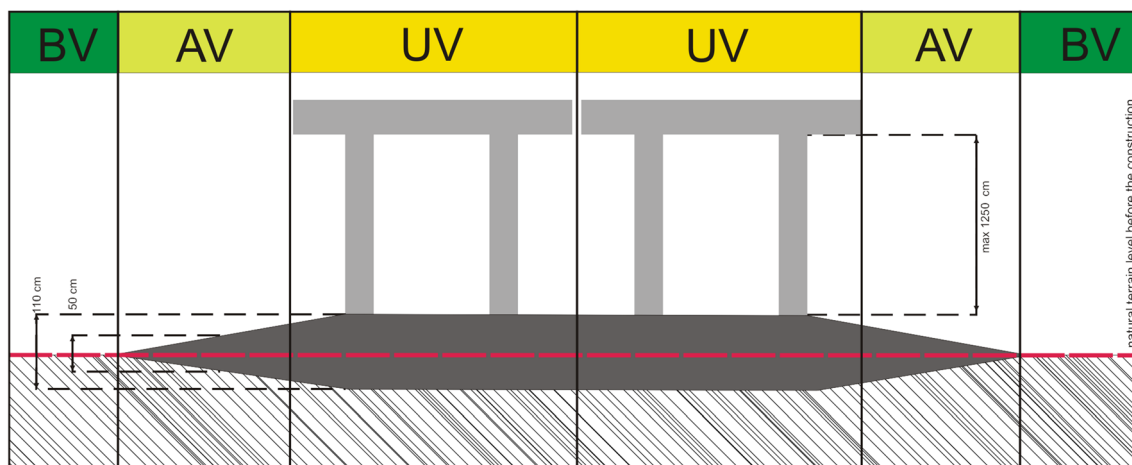
**Fig. 1** Location of the study transects divided into three zones (UV under the viaduct, AV adjacent to the viaduct, BV beyond the viaduct)—transverse projection

The study area was divided into three zones, different in terms of the disturbance extent and the current habitat conditions. The zones covered the area from the viaduct axis to the areas situated beyond the right-of-way (Fig. 1).

Zone 1—under the viaduct (UV). An approximately 18-m-wide area directly under the viaduct, totally devastated during the construction of the bridge.

Zone 2—adjacent to the viaduct (AV). An approximately 15-m-wide area within the right-of-way but outside the inside diameter of the viaduct, totally devastated during the construction of the bridge.

Zone 3—beyond the viaduct (BV). An area beyond the right-of-way, in the immediate vicinity of the transformed areas, the valley's floor covered with peat, not disturbed by the construction of the bridge.

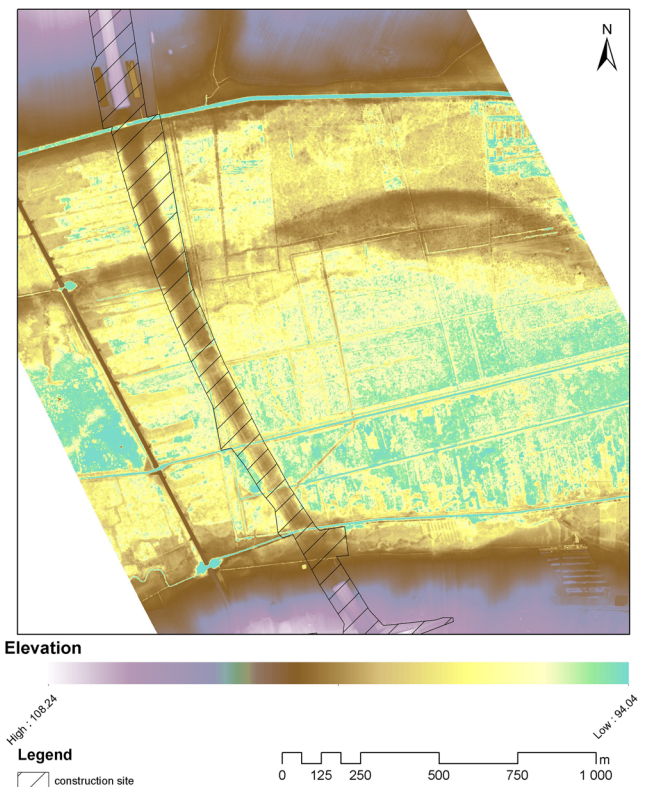
**Fig. 3** Digital terrain model created from the point cloud collected in 2014—after the highway construction

DTM produced in 2014 shows an embankment along the entire right-of-way that runs across the river valley floor (Fig. 3). The embankment is currently elevated by a maximum of approximately 1 m over the natural terrain elevation (max. 95.8 m above sea level) and is approximately 80-m wide. The embankment is situated within the right-of-way. The terrain elevation profile across the right-of-way created in 2011 and 2014 shows that the embankment was built during the highway construction and is located in what used to be a flat area at approximately 94.8 m above sea level before the project has started. The embankment reaches the maximum height within the highway's axis and then gradually descends to approximately 0.5 m at the borderline of the UV/AV zones and then further descends up to the end of the right-of-way (AV/BV zones' borderline) to disappear completely (Fig. 4).

the land reclamation, and 1 year after the project completion, they still pose a serious threat to the valley ecosystems. The first barrier is the embankment (Figs. 3 and 4), and the other one is compressed peat under the bridge.

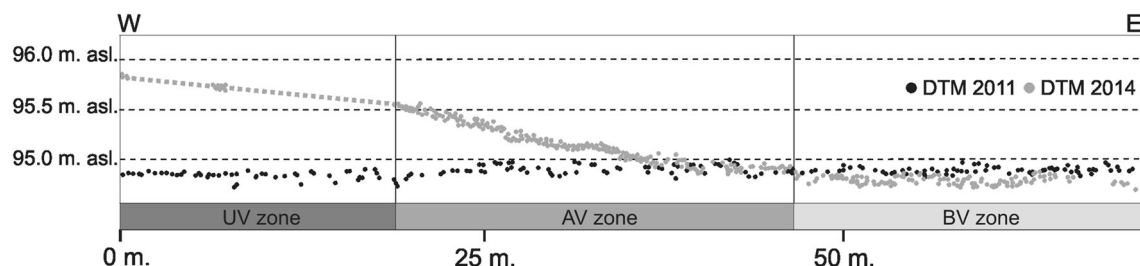
**Fig. 4** Profile for two point clouds from 2011 and 2014

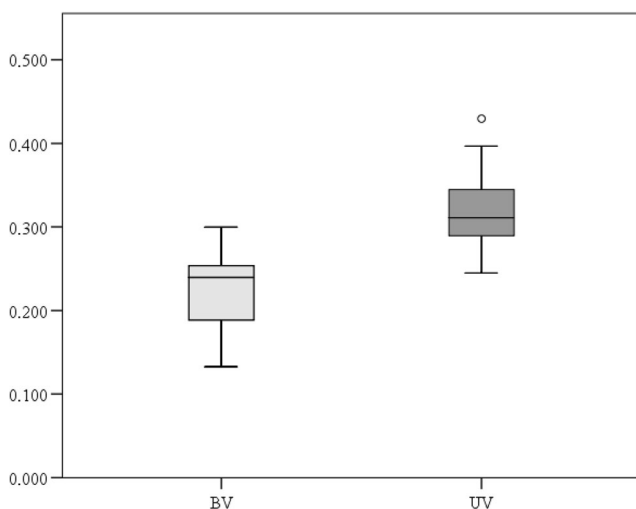
**Fig. 5** Comparison of the peat bulk density between the UV and BV zones. The average bulk density was significantly different, according to the independent  $t$  test ( $t=9.431$ ,  $p<0.005$ )

is located under the viaduct. The embankment is composed of sand and concrete rubble which in many places form a solid cover. The embankment's thickness in the viaduct axis ranges from 60 to 140 cm, on average ca. 100 cm. Further from the viaduct axis, the thickness of the soil overlay decreases, ranging from 55 to 100 cm and reaching approximately 70 cm at the borderline of the UV/AV zones. A highly decomposed peat layer (black color) is deposited directly under the embankment, underlain by brown herbaceous peat whose substratum is composed of organic mud or mineral sand with mud. The total thickness of biogenic deposits varies at different sites along the viaduct and ranges from 40 to 175 cm. The average thickness of peat and organic mud in this zone is 80.5 cm. The peat under the embankment is highly compressed. The mean bulk density of peat in the UV zone is  $0.318 \pm 0.041$ , while in the BV zone— $0.223 \pm 0.043$  (Fig. 5). The difference between these values is statistically significant ( $t=9.43$ ;  $p<0.001$ ).

beyond the viaduct (BV) indicated an increase in the bulk density of about 142 %. Consequently, the horizontal water flow in the ground is reduced. The embankment across the valley floor has a similar effect as it hinders free migration of surface water, which greatly affects the natural vegetation of the river valley floor (Bunn and Arthington 2002; Tockner and Stanford 2002). It may affect the local hydrology by reducing the water permeability of the soil, affecting the natural moisture balance and reducing the water inflow (Price and Schlotzhauer 1999; Charman 2002; Rydelek 2011). In the case of wetlands fed by groundwater seeping in the basin slope zone, the existence of a barrier in the form of an embankment has a limited effect on the groundwater level (Wielechowska and Mioduszeński 2003). However, it is very important to the water filtered through the peat deposit or running off the surface, which is the case at the study site. The water level will probably rise in front of the embankment and lower below the embankment (Hartlén and Wolski 1996). The permanent lowering of the water table in some places and the rising water table in others will basically affect the composition of plant communities in the long term. However, the area and the extent of changes, and the response of the ecosystem to the construction of the road will greatly depend on the relief of the valley floor (Fig. 3). For example, the presence of the artificial canal which runs across the UV zone will mitigate the negative impacts of the physical barrier.

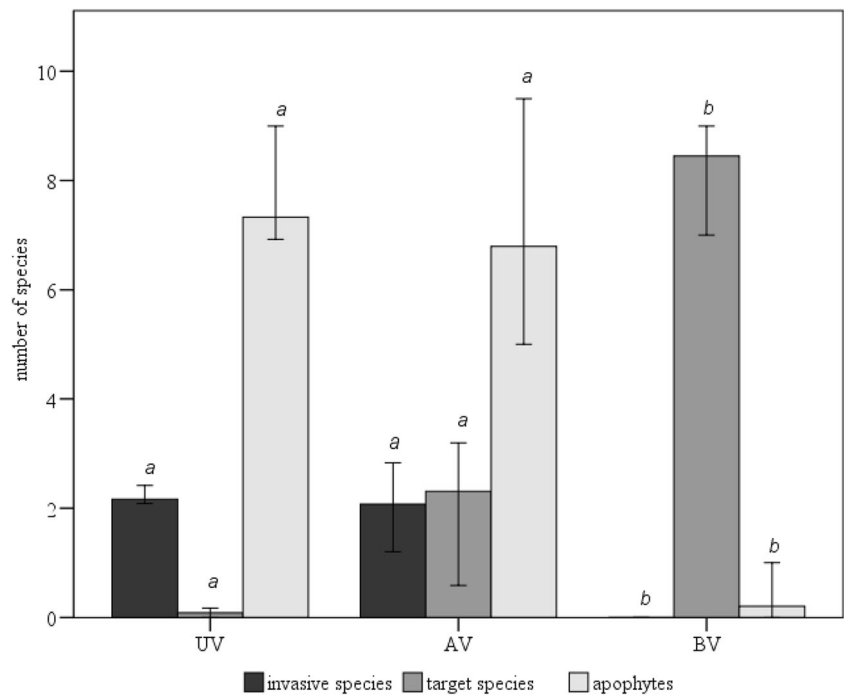
**Fig. 6** Comparison of the number of apophytes ( $H=10.186$ ,  $p<0.05$ ), invasive ( $H=9.981$ ,  $p<0.05$ ), and target species ( $H=20.912$ ,  $p<0.001$ ) between the UV, AV, and BV zones. Boxes with the same letter are not significantly different, according to the Kruskal-Wallis and Dunn post hoc tests

The analysis of the distribution of apophytes and IAS in the profile running across the right-of-way showed that their highest average number occurred between the 14th and 30th meter from the viaduct axis at the borderline of the UV/AV zones. The average number of apophytes and IAS not different significantly between UV and AV zone (Fig. 6). The highest density of these species was observed (apophytes—10 species/4 m<sup>2</sup> and invasive species—3.1 species/4 m<sup>2</sup>) in areas where the embankment is approximately 0.4-m high and the light penetration is only slightly limited by the viaduct. Invasive species and apophytes occur only at sites located in the immediate proximity of the right-of-way, with small density in the BV zone. The average number of apophytes and invasive species in BV zone was significantly lower than in UV and AV zone (Fig. 6).

The analysis of the target species distribution indicated that most of them occurred only in the BV and AV zones (Fig. 6). The average number of target species in the UV and AV zones was not significantly different (Fig. 6). *Lythrum salicaria*, *Rorippa palustris*, and *Polygonum amphibium* (Fig. 9) were also found in the UV zone, but their average cover was below 2.0 %. Rush species were much more frequent and abundant in the AV zone. Two of them—*L. salicaria* and *Juncus articulatus*—were identified as indicators of this zone. Generally, a significantly larger contribution of target species was observed in plots situated farther than 24 m from the highway axis where the embankment was not higher than 0.2 m. *L. salicaria*, *Typha latifolia*, *R. palustris*, *Alisma plantago-aquatica*, and *J. articulatus* were frequently observed in the zone located between the 24th and 44th meter from the highway axis. Among these species, *L. salicaria* reached the highest average cover (33.0 %) at the sites situated 40 m from the viaduct axis, and *T. latifolia* (with average cover of 21.3 %) at the sites situated 42 m from the viaduct axis.

The results of soil, botanical, and remote sensing studies show that in order to reduce the adverse environmental impact of the investment, it is necessary to implement a number of restoration actions because those applied during the construction works proved ineffective. (a) The most important task is to level the terrain once again. Moisture conditions (Fig. 8) currently prevailing in the UV and AV zones prevent the development of rush vegetation (Figs. 6 and 9). The analysis of the target species distribution in the cross section shows that if the embankment is lowered to the maximum height of 0.2 m, rush vegetation should regenerate spontaneously. (b) The light conditions (Fig. 8) currently prevailing in the UV zone prevent the growth of rush vegetation (Figs. 8 and 9). For this reason, the restoration process should be supported by hay transfer, which is a commonly used method in the restoration of wetlands (Klimkowska et al. 2010; Rasran et al. 2007; Hedberg et al. 2014; Schmiede et al. 2013). The biomass should come from the floodplain forest, and not from open ecosystems adjacent to the construction site (not from the BV zone). The light conditions under the viaduct (Fig. 8) are similar to those prevailing in the undergrowth of floodplain forest (Czerepko 2007), i.e., a climax community of the Bzura valley (Kopeć et al. 2014a). (d) It is also necessary to eliminate weed species from the AV and BV zones. Although their cover-abundance is still small 1 year after the construction (Fig. 6).

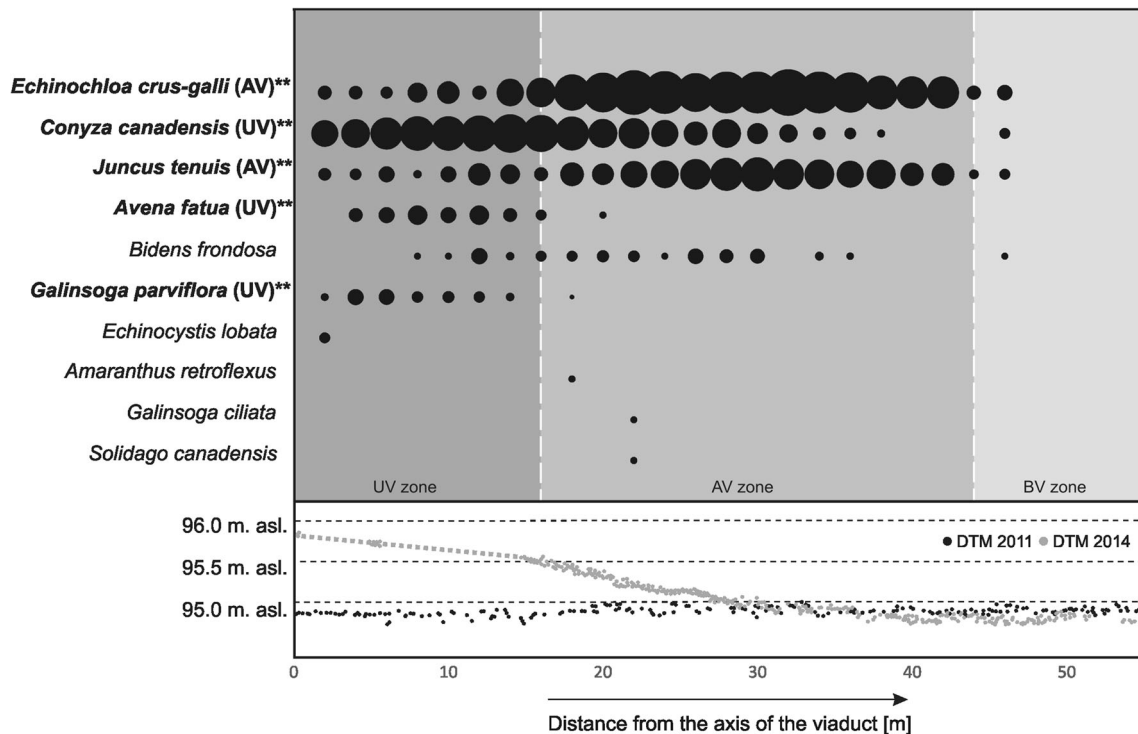
**Fig. 7** Average percentage cover of individual invasive species at sites located at certain distances from the highway axis. Values calculated for 12 transects. The area of a circle corresponds to the average percentage cover of a given species at a given site. Species in bold are significantly

correlated (IndVal analysis) with one of the three zones ( $*p<0.05$ ,  $**p<0.005$ ); a code of this zone is provided in brackets. In the lower part of the figure, cross-section elevation profiles are presented, prepared by laser scanning using the data collected in 2011 and 2014

Among the invasive species, *Galinsoga parviflora*, *Avena fatua*, and *Conyza canadensis* were significantly correlated with the UV zone (Fig. 7). The maximum average cover of these species was between the 4th and 10th meter from the viaduct axis (2.2, 2.5, and 12.5 %, respectively).

cover ranged from 14.5 to 21.3 %. *Juncus tenuis* was yet another species noted with the maximum cover in the AV zone. Both of them are statistically significantly associated with the AV zone (Fig. 7). The average cover of this

The conducted analysis of the flora shows that weed species occur in the BV zone (Figs. 6 and 7). *B. frondosa* and *J. tenuis* observed in the BV zone already 1 year after the construction was completed, and which migrated from the UV and AV zones, are particularly dangerous for the semi-natural wetland communities surrounding the construction site (Fig. 7). The species occur now in wetland communities of the Bzura valley (Kopeć et al. 2014b) and are considered one of the most widespread alien plant species in Europe (Lambdon et al. 2008). They are likely to extend their cover in the BV zone in the following years, displacing the native flora species due to their expansiveness (Otto et al. 1994; Danuso et al. 2012; Myśliwy 2014). The observed changes in BV indicate that the ecological impact of the road with the under-viaduct-embankment involves a considerably larger area than that covered by the road itself (see Wemple et al. 1996; Jones et al. 2000).

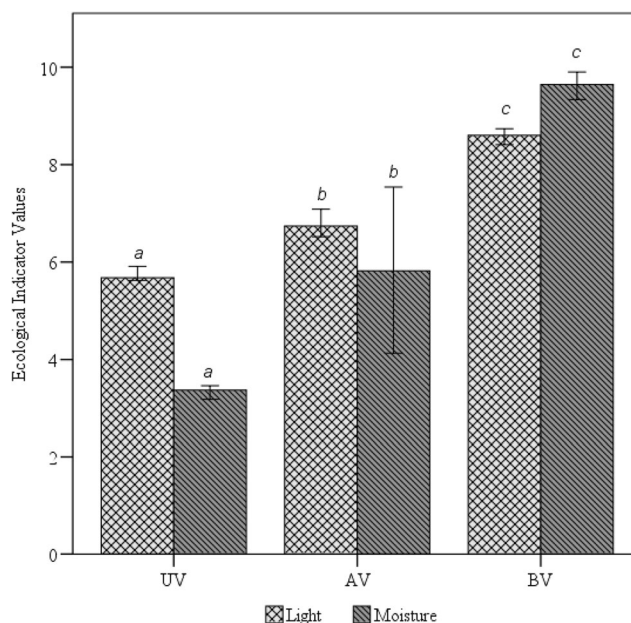
**Fig. 8** Comparison of the light ( $H=21.257$ ,  $p<0.005$ ) and moisture ( $H=21.358$ ,  $p<0.005$ ) EIVs between the UV, AV, and BV zones. Boxes with the same letter are not significantly different, according to the Kruskal-Wallis and Dunn post hoc tests

Light and moisture EIVs varying in the cross-section profile had a similar pattern. The average EIVs of light and moisture were significantly different in all three zones (Fig. 8). Extremely low values were recorded in the UV zone, where moisture values ranged from 3.1 to 3.8, and were associated with the embankment of over 0.5 m in height. The value indicated that the conditions were favorable to dry-site species. Light indicator values under the viaduct ranged from 5.6 and 6.0, which corresponds to the conditions favorable to semi-shade plants. The AV zone had higher increases in the moisture and light EIVs; however, the average values of these indicators did not reach the values characteristic of the BV zone. In the BV (reference) zone, the moisture indicator values ranged from 9.0 to 10.0, and light indicator values ranged from 8.3 to 8.8, which corresponds to wetland conditions and intense sunlight.

The ecological profile of floras in UV, AV, and BV zones is significantly different in terms of light EIVs (Fig. 8). The UV zone with the elevated ground surface is colonized by semi-shade plants (Fig. 8). The further away from the bridge, the

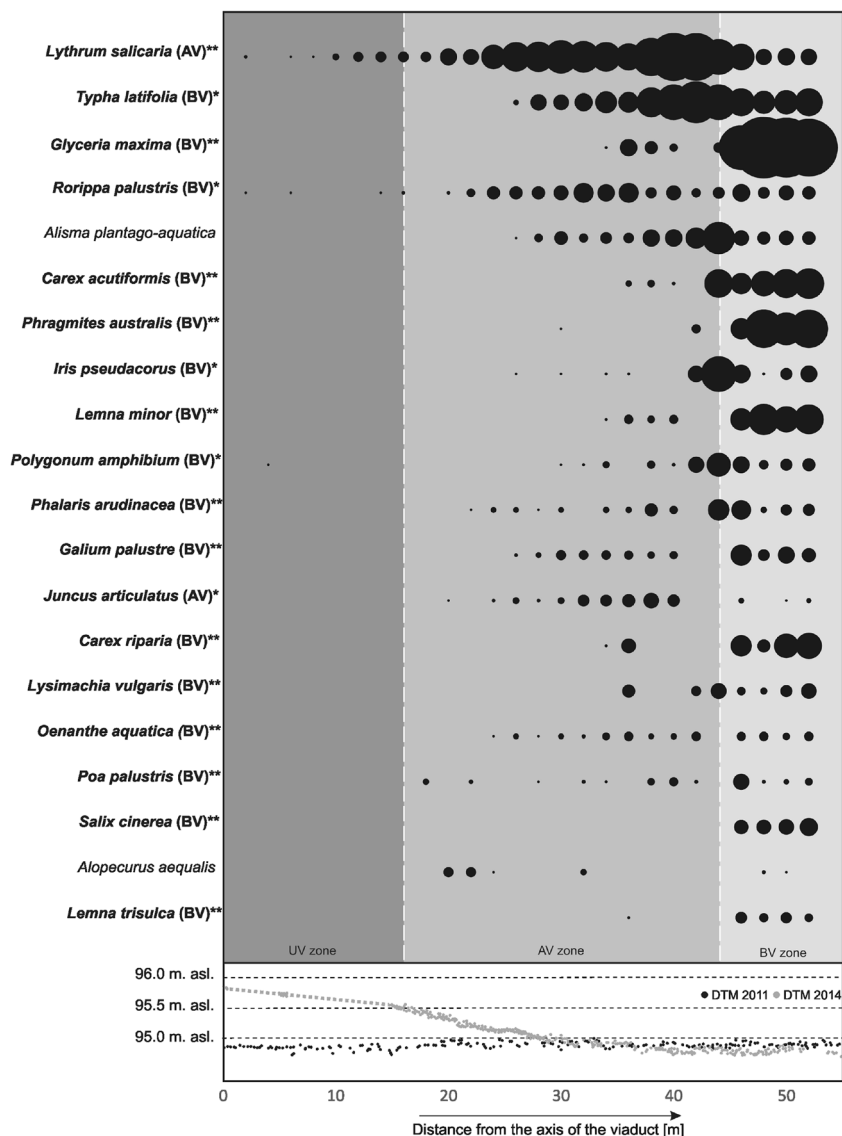
**Fig. 9** Average percentage cover for individual target species at sites located at certain distances from the highway axis. Values calculated for 12 transects. The area of a circle corresponds to the average percentage cover of a given species at a given site. Species in bold are significantly correlated (IndVal analysis) with one of the three zones (\* $p < 0.05$ , \*\* $p < 0.005$ ); a code of this zone is provided in brackets. In the lower part of the figure, cross-section elevation profiles are presented, prepared by laser scanning using the data collected in 2011 and 2014
